STEP BY STEP INSPECTIONS

RESIDENTIAL INSPECTION

1733 Combahee St
Charleston, SC 29412

Neil Girardi
MARCH 16, 2022

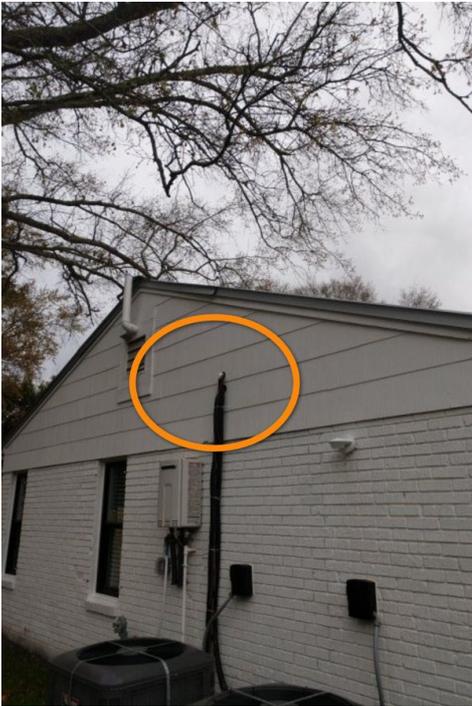
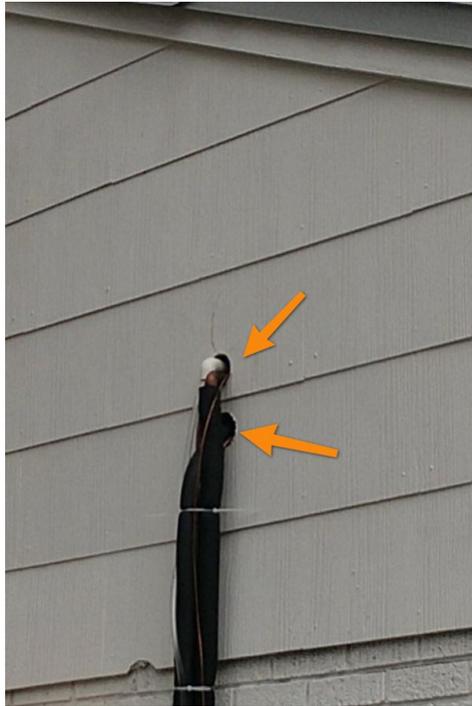
Left Side

2.1.1 EXTERIOR SIDING

Visible gaps noted around the perimeter of the home. All open gaps should be sealed to help prevent potential deterioration and water entry. See photo(s) for examples.

Contact a qualified professional.

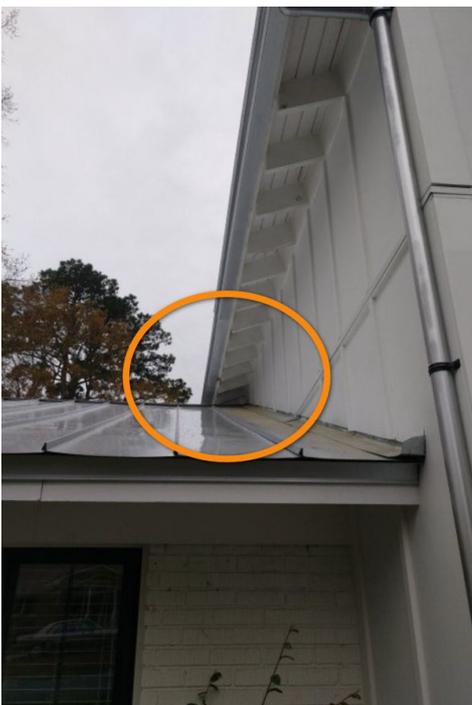
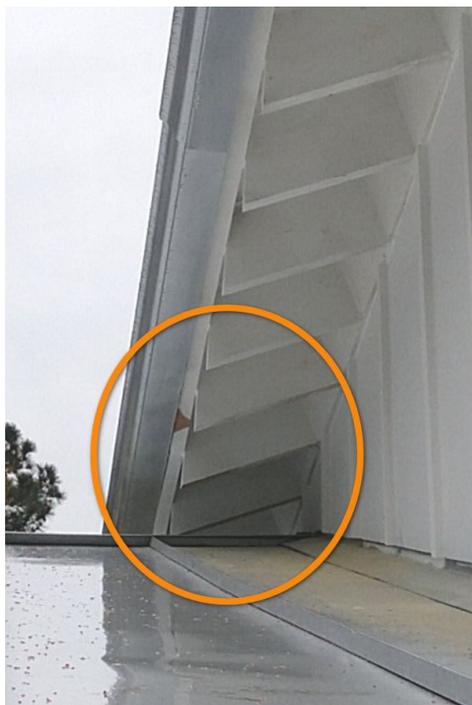
Front

2.2.1 EXTERIOR WOOD TRIM
PAINT EXTERIOR TRIM

Paint is peeling and/or deteriorated on the exterior trim and will likely need to be painted in the near future. Typical homeowner maintenance suggests that homes be painted every 3-5 years. See photo(s) for example(s).

Contact a qualified professional.

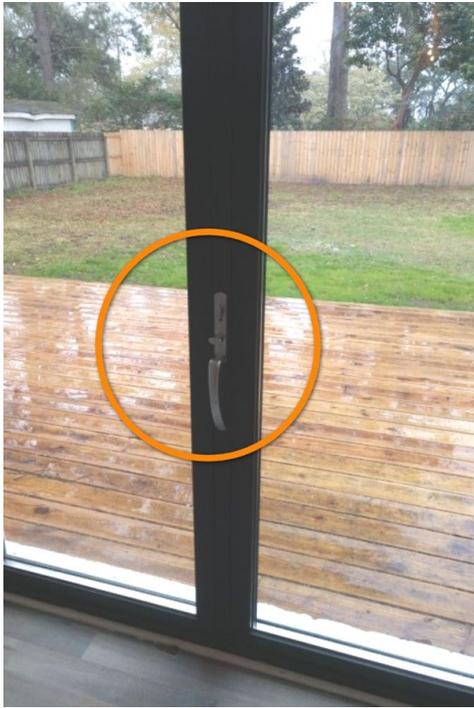
Rear

2.5.1 DOORS (Exterior)

Hardware issue is evident on exterior door. Repair as needed. See photo(s).

Contact a qualified professional.

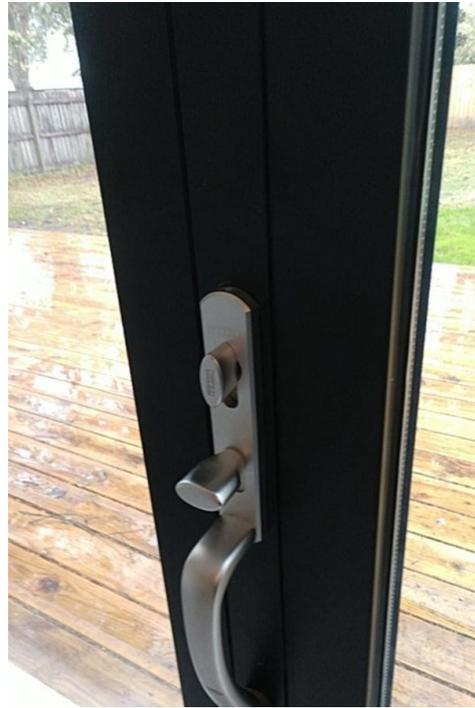
Can't open

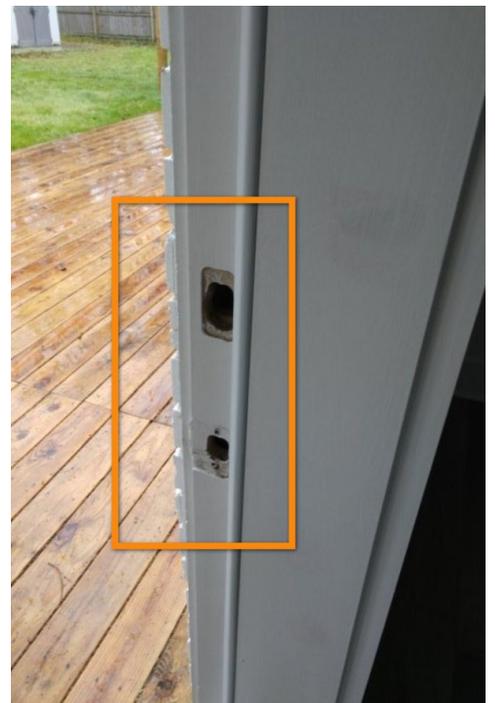
Rear Master Bedroom

LATCH PLATE MISSING

Latch plate is missing at exterior door. Damage can/has occur to door/jamb. Replacement of plate is needed. See photo.

Contact a qualified handyman.

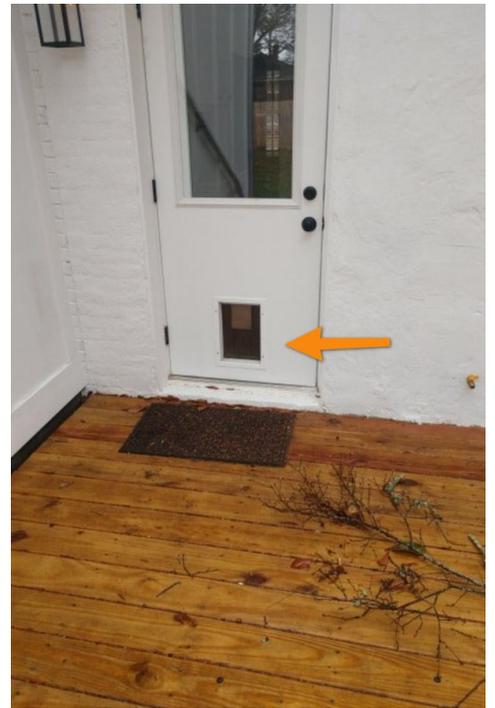
Rear

2.5.3 DOORS (Exterior)

Pet door installed at exterior door. Insects may enter or this can cause energy loss. Recommend replace door as needed. See photos.

Contact a qualified professional.

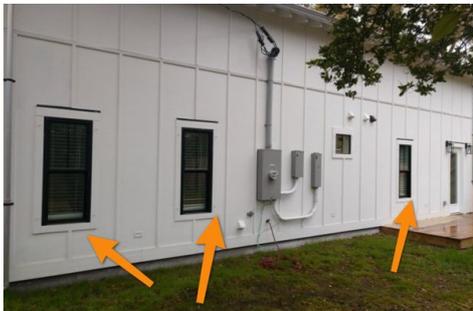
Right Side

2.6.1 WINDOWS(Exterior)

Window screen(s) not installed. Recommend replace / add screen(s) as needed.

Contact a qualified professional.

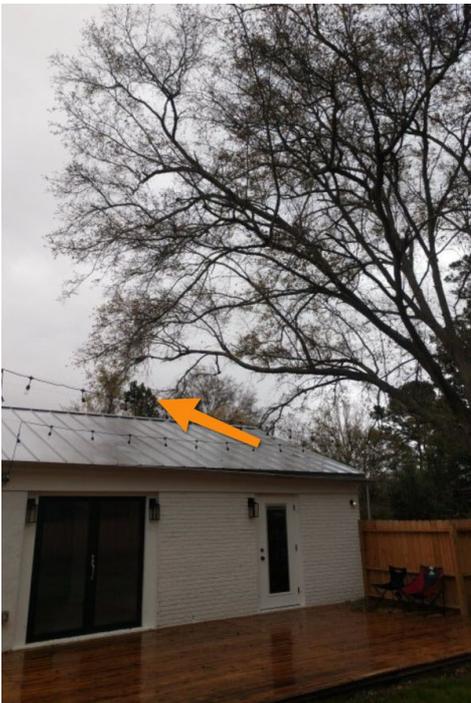
Rear

Tree limbs are in contact with roof or are hanging near roof. All limbs should be trimmed at least 5' away. This will help prevent damage to the roof surface and may help prevent rodent entry into the attic. See photo(s) for example(s).

Contact a qualified tree service company.

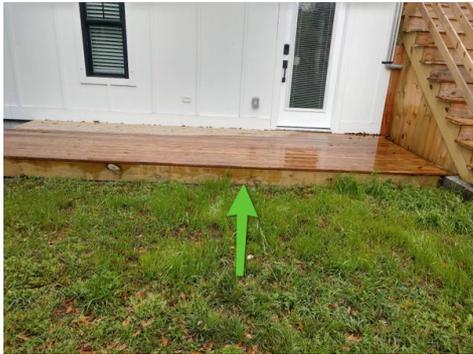
Right Side

LIMITED VISUAL

Limited visual of framing under deck(s) due to low clearance to the ground. Framing was observed from the edge. Framing and attachment method is not fully known and cannot be confirmed.

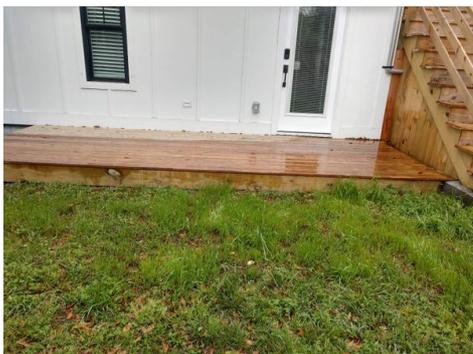
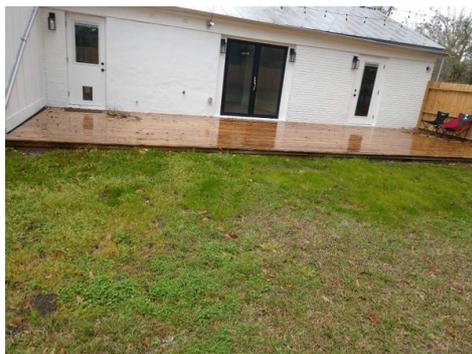
LIMITED VISUAL - CLEARANCE TO GROUND

Limited visual of framing under deck due to low clearance to the ground. Framing was observed from the edge. See photo(s).

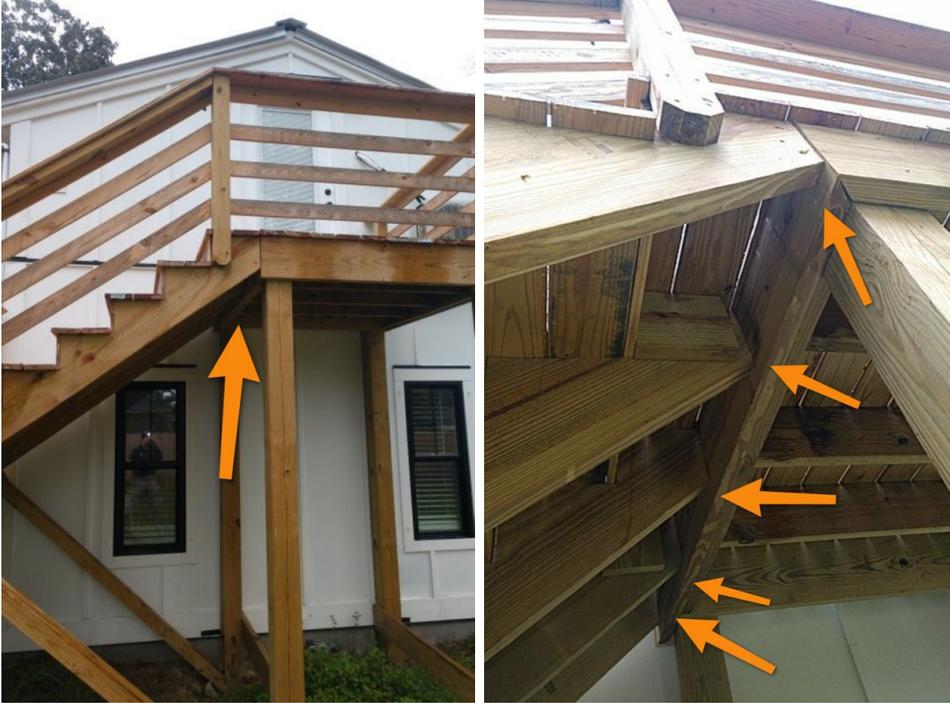
Rear

3.2.1 STEPS / LANDING

STRINGERS - HANGERS MISSING

Contact a qualified professional.

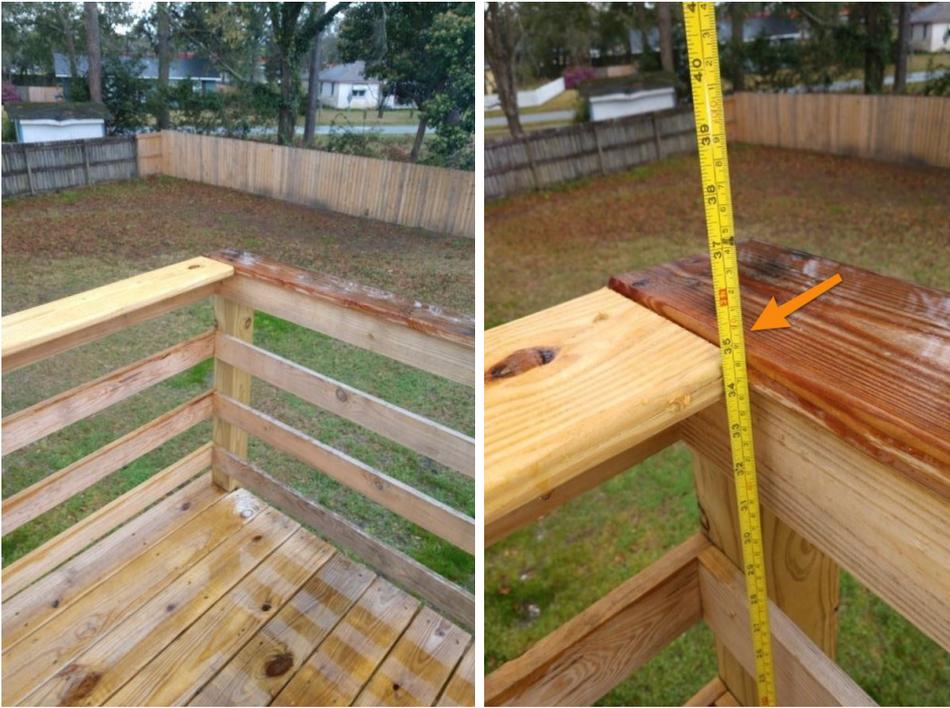
35 in

3.4.1 RAILS / BARRIERS

INADEQUATE RAIL

Rails are inadequate. Rail barriers should be at least 36" high and should have vertical spindles to prevent small people from falling through or getting stuck in the spindles. See photo(s).

Contact a qualified professional.

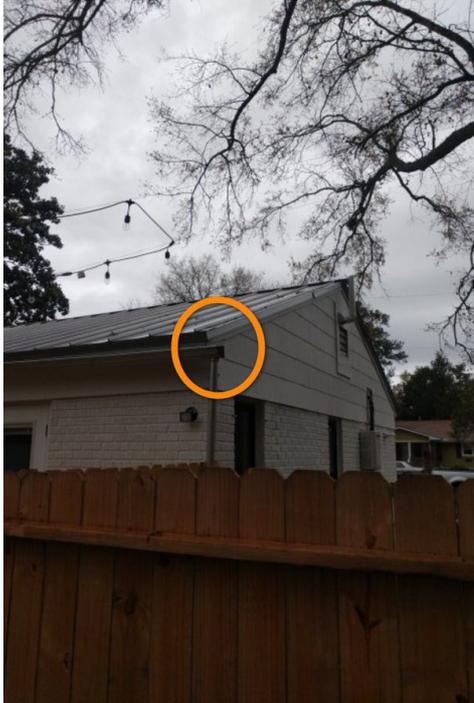
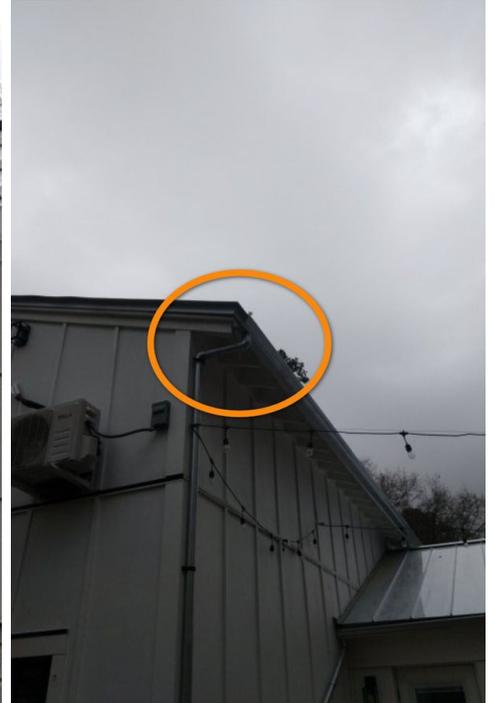
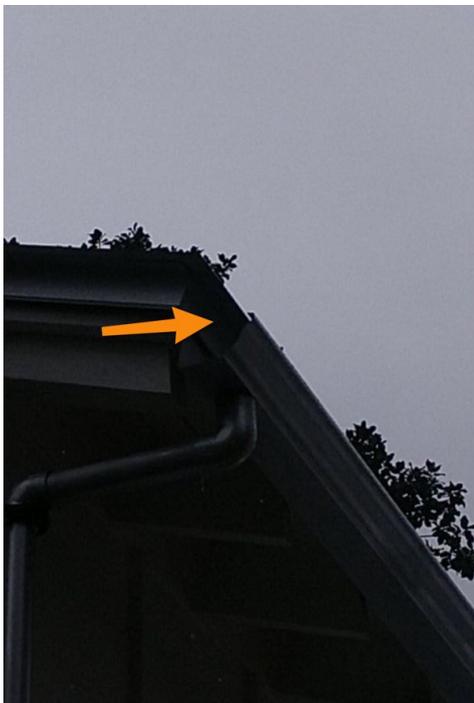
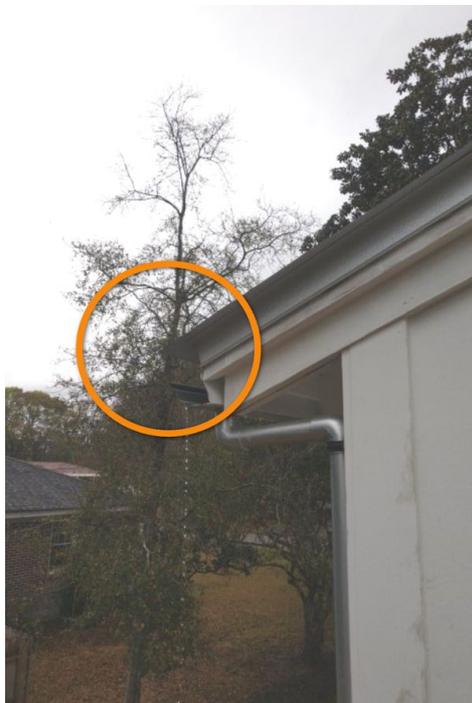
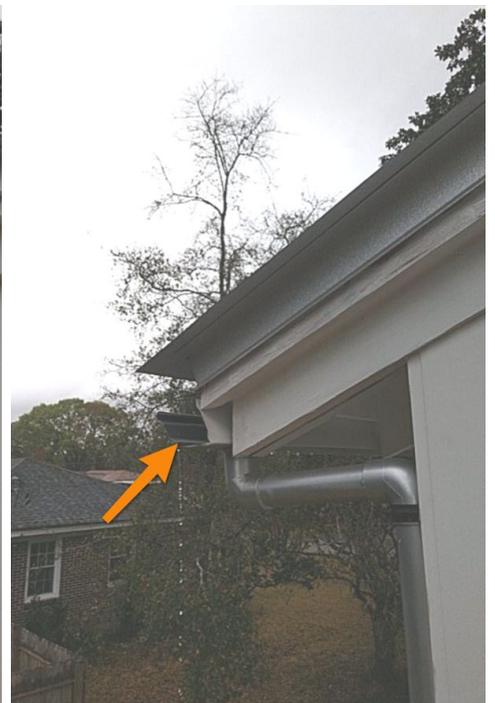
Left Side

4.4.1 GUTTERS and DOWNSPOUTS

END CAP MISSING

End cap is missing on gutter. End cap is needed for proper drainage. See photos.

Contact a qualified handyman.

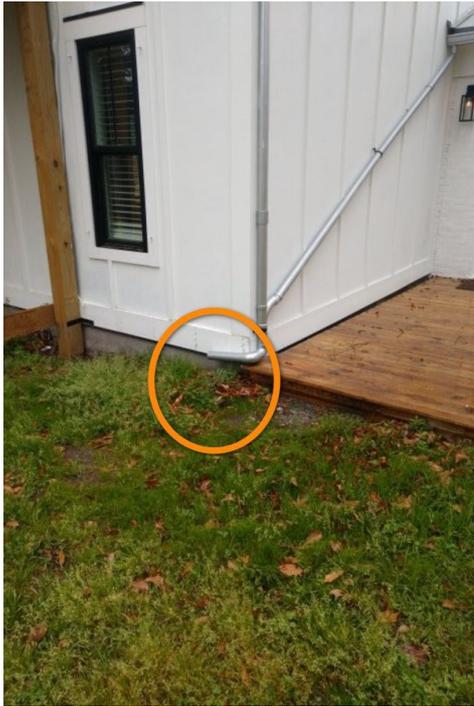
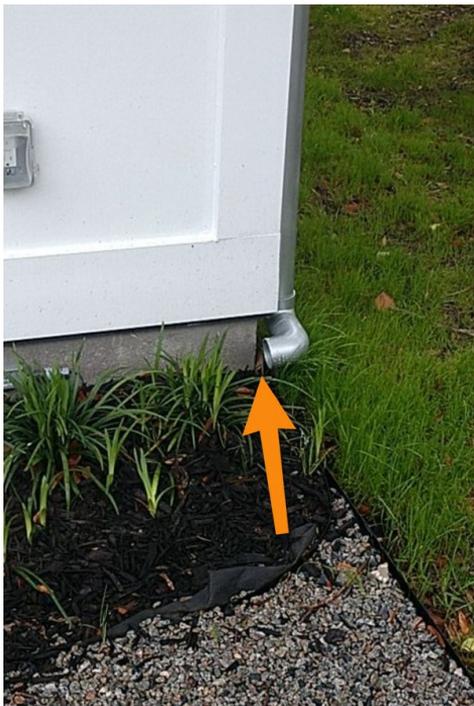
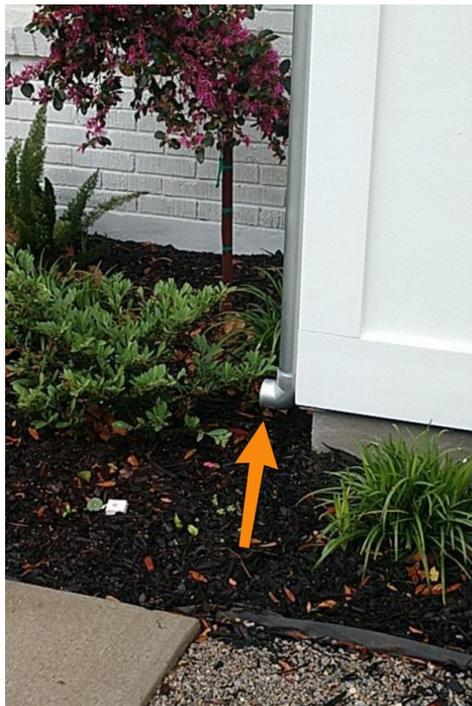
Rear

4.4.2 GUTTERS and DOWNSPOUTS

DOWNSPOUTS - EXTENSIONS RECOMMENDED

Water is draining from the downspout near the foundation of the home. Downspout extensions may help resolve this issue. All roof water should drain at least 5 feet away from the home. See photo(s).

Recommendation
Contact a qualified handyman.

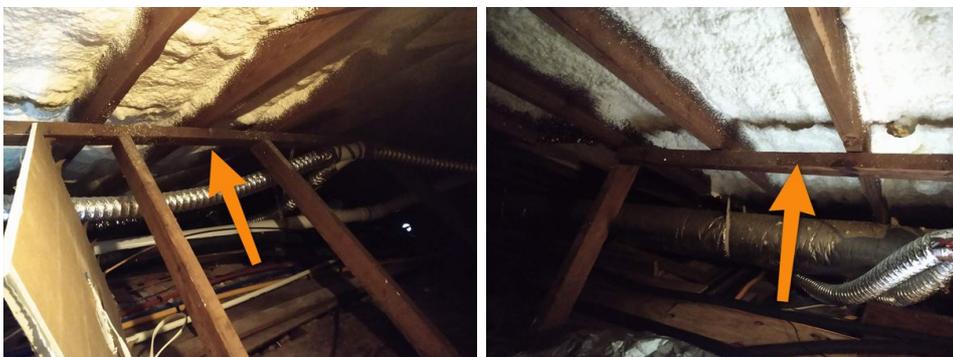
Existing purlin & struts (horizontal bracing for the rafters) do not appear to be adequately supporting the rafters in the attic. Purlins shall be sized not less than the size of the rafter and braced every four feet. This system helps prevent rafter sag which can eventually lead to broken rafters. See photo(s).

Contact a qualified professional.

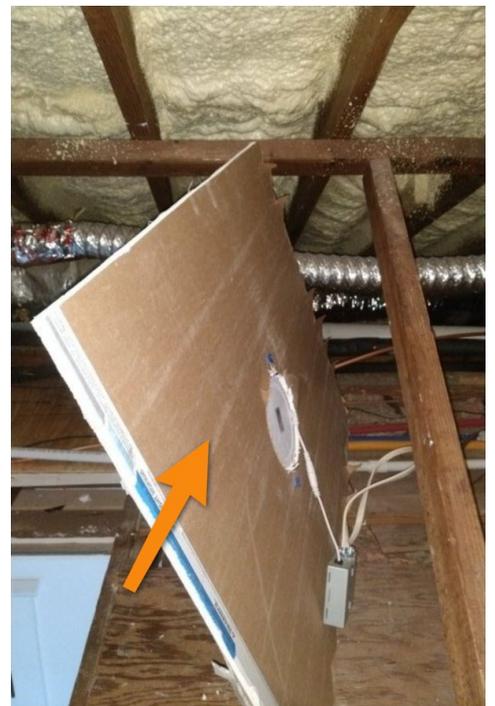
5.2.1 ATTIC ACCESS DOOR, PANEL, PULL DOWN STAIR

NO INSULATION ATTIC PANEL

Contact a qualified handyman.

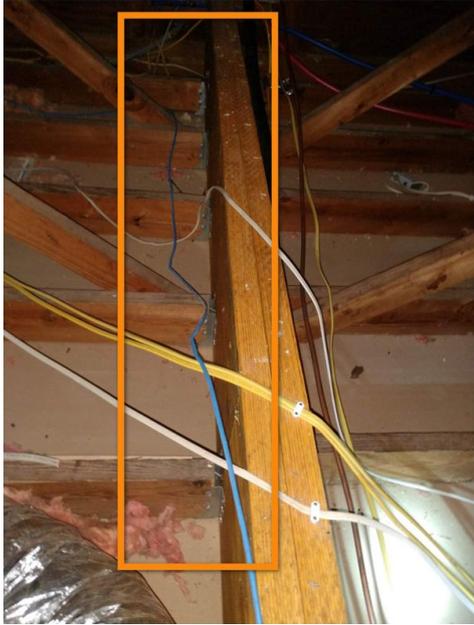
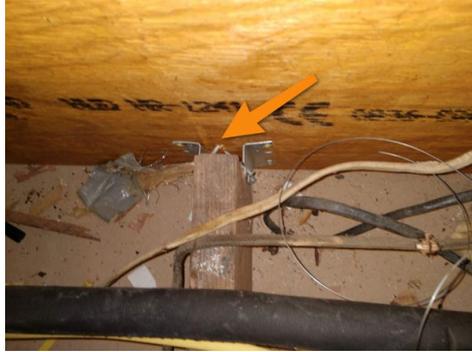
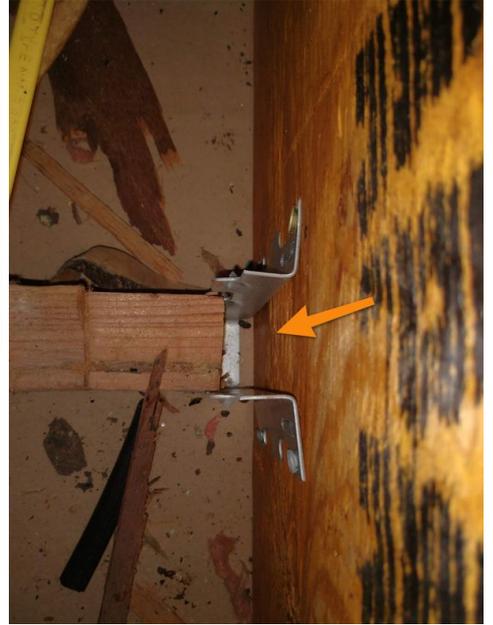
5.4.1 WALLS (Structural)

LOAD BEARING WALL REMOVED

A load-bearing wall has been removed from the home. Doubled LVL joist have been installed in the attic space, however ceiling joist appear to have been cut back too far to allow proper connection to the LVL beams. Nails on some brackets are not embedded enough into the joist to provide any support. Recommend further evaluation by a licensed contractor/ or a structural engineer. Additionally I recommend that the seller provides documentation of building permits and signed off inspections by the city/county. See photos for examples of this area.

Contact a qualified professional.

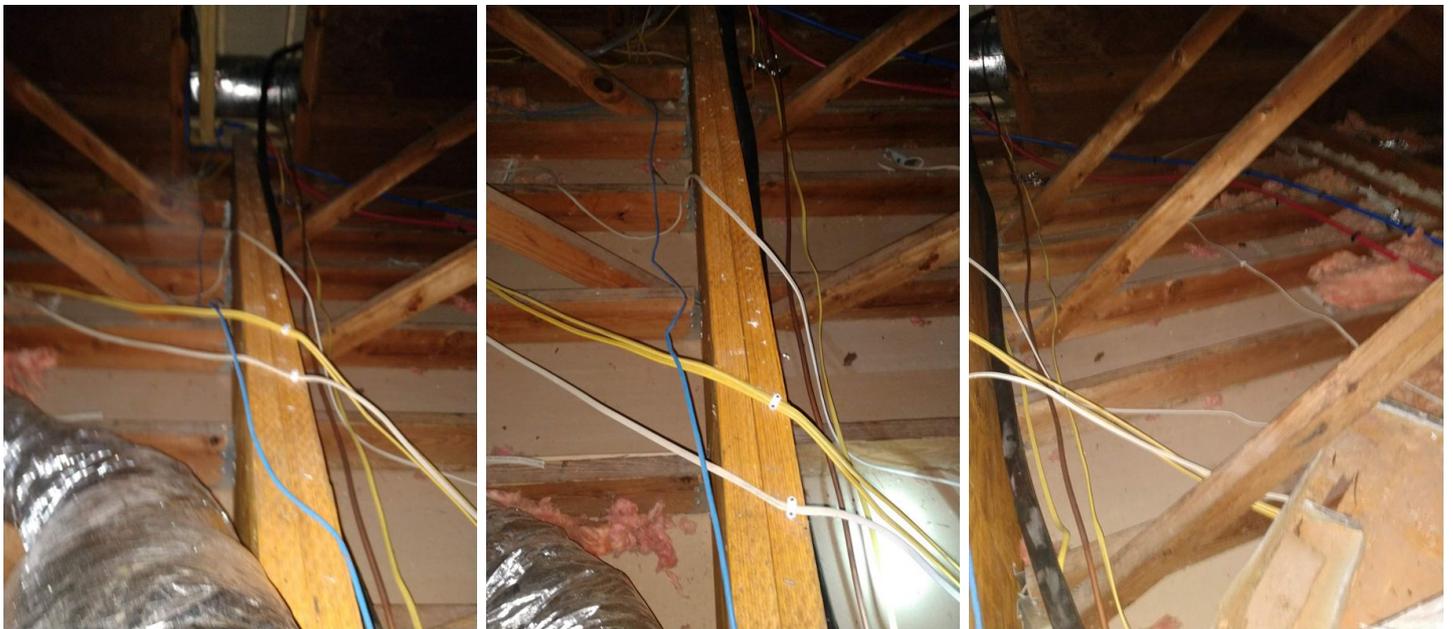
MISSING INSULATION

Insulation is missing in area(s). This is not energy efficient and should be corrected. See photo(s).

Contact a qualified professional.

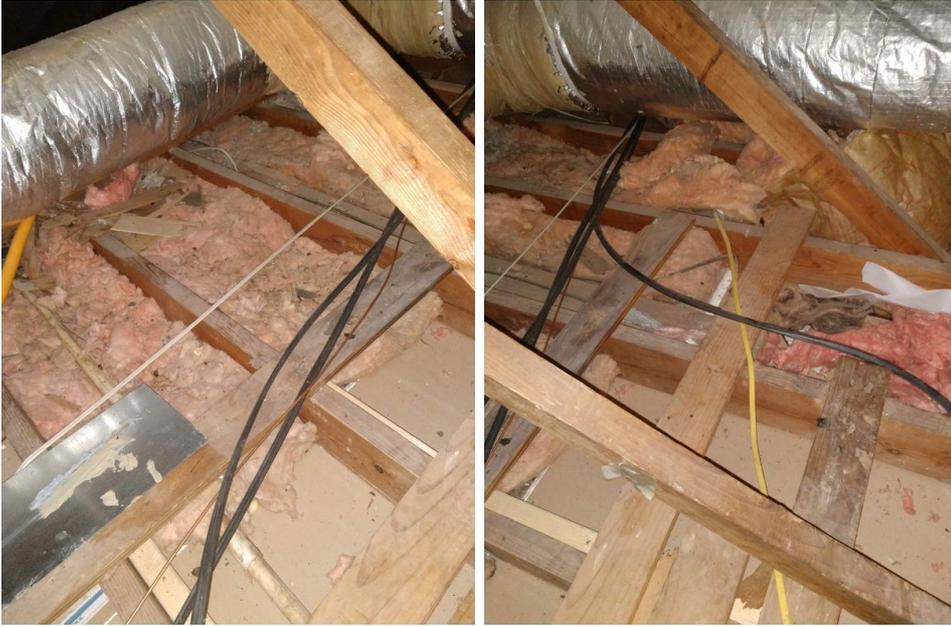
6.1.2 INSULATION IN ATTIC

LOW INSULATION LEVELS - LESS THAN R-30

Insulation has settled throughout the attic and the ceiling joists are visible. Additional insulation is recommended to provide better energy efficiency. Current standards suggest a minimum of R-30. See photo(s).

Contact a qualified professional.

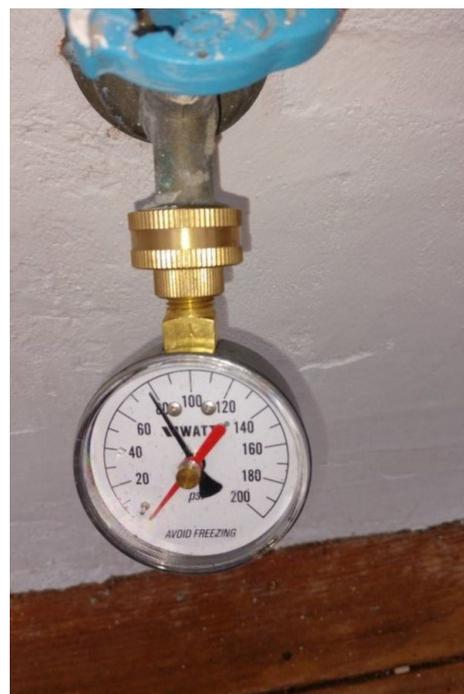
Water pressure at time of inspection. See photo.

79 psi

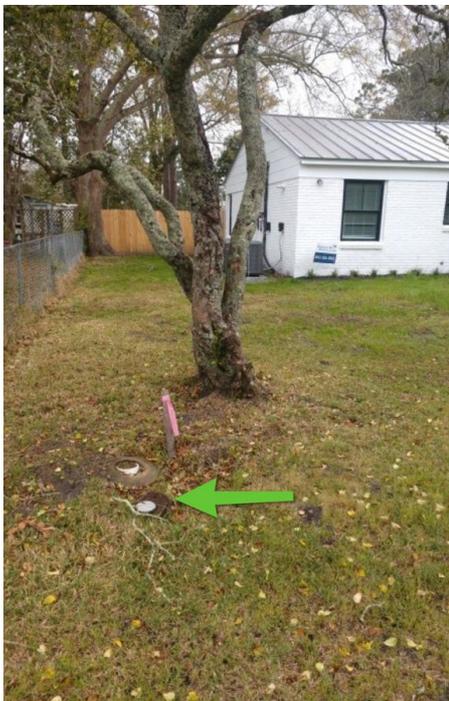
Front

View of Main Water shut-off.

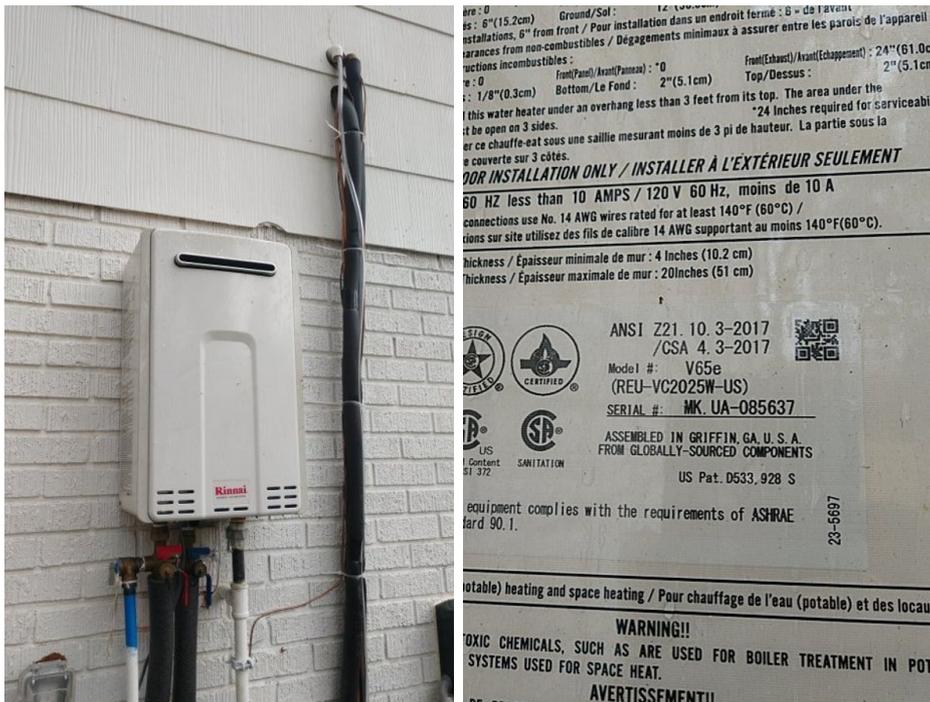
View of the Water Heater(s).

WATER HEATER: Tankless Water Heater Service

Service recommended on the tankless water heater. Tankless or demand water heater manufacturers require periodic maintenance of the units to ensure they will have a long life. This usually entails a cleaning and flushing of the system to prevent clogs and scale build up. Failure to maintain units can lead to pre-mature failure. It is not clear when the last time the unit(s) were serviced.

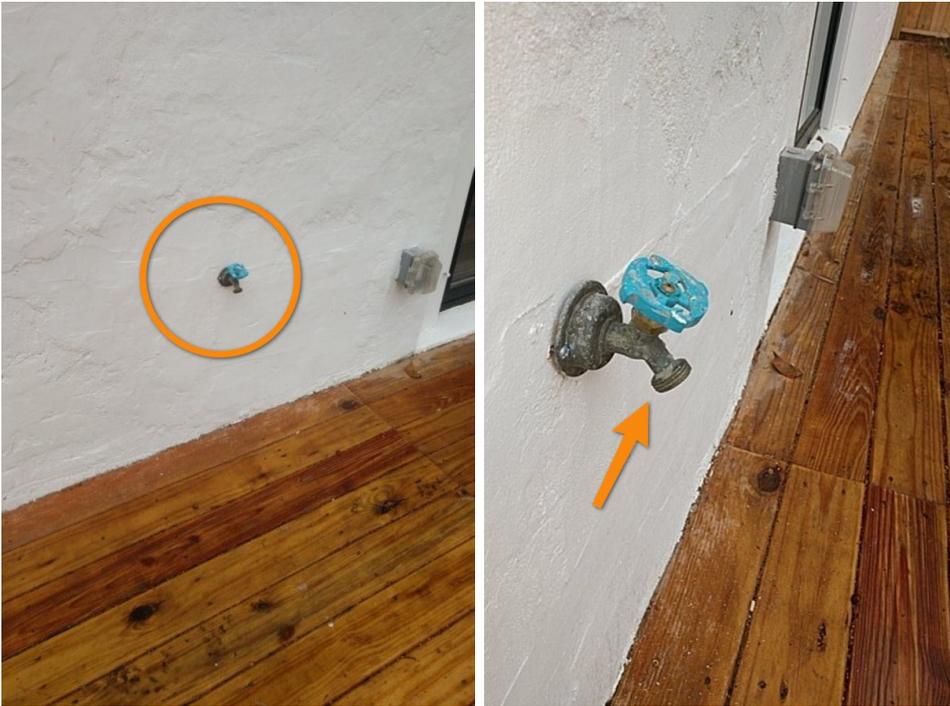
Rear

Recommend to have vacuum breakers installed on each of the exterior faucets. This will help prevent cross contamination when the faucets are used. This was not required on older homes.

Contact a qualified professional.

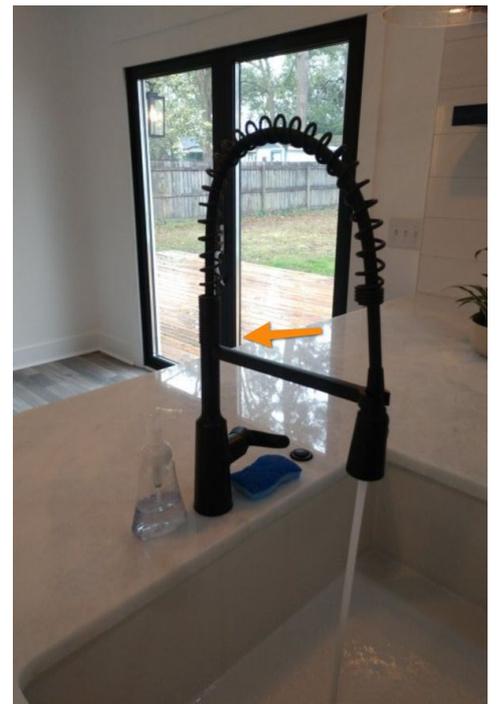
Kitchen

7.3.1 SINKS

SINK FIXTURE LOOSE

Sink fixture is loose. Loose fixtures may begin to leak or break. Repair needed. See photo(s).

Contact a qualified professional.

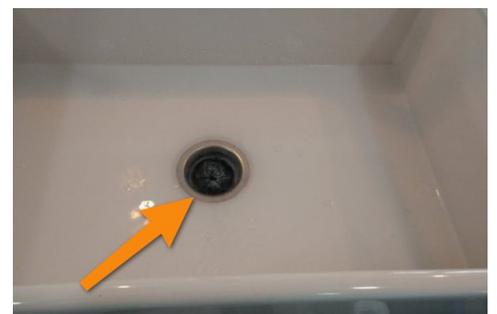
Kitchen

7.3.2 SINKS

Slow drain noted for the sink. Recommend to have drain line checked for possible clog. See photo(s)

Contact a qualified plumbing contractor.

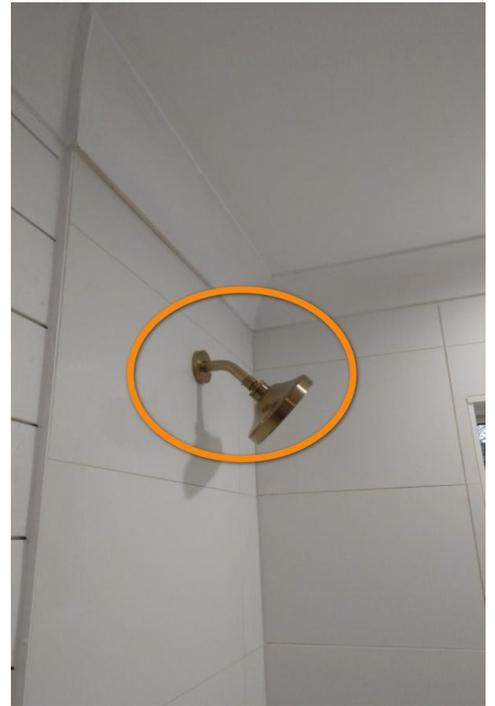
Right Side Hall Bath

7.4.1 SHOWERS and TUBS

TUB / SHOWER FIXTURE LOOSE

Tub / shower fixture is loose. Loose fixtures may begin to leak or break. Repair needed. See photo(s).

Contact a qualified professional.

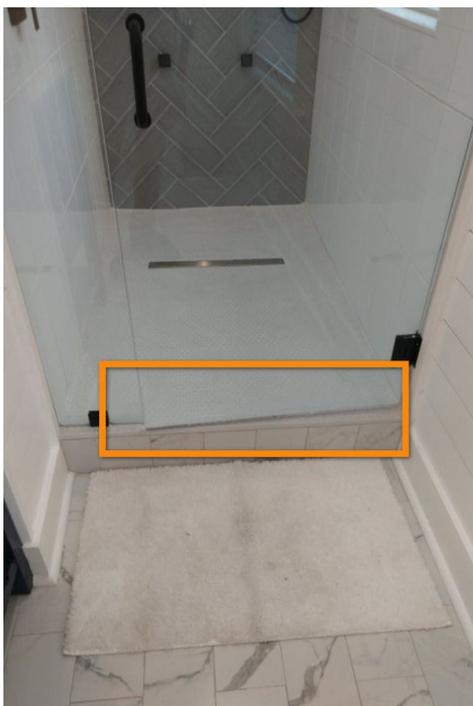
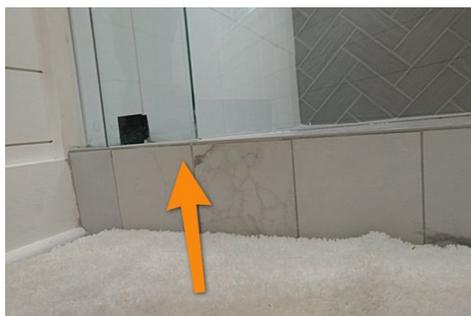
Master Bath

7.4.2 SHOWERS and TUBS

SHOWER DOOR SEAL MISSING/WORN

Shower door has missing/worn lower seal. The seal strip is intended to prevent water from splashing out on the floor through the bottom of door when shower is in use. Repair needed. See photo(s).

Contact a qualified professional.

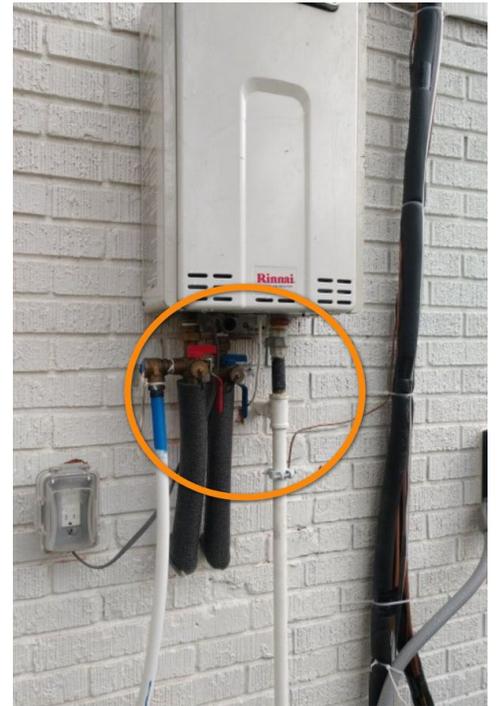
Left Side

7.7.1 GAS PIPING AND DISTRIBUTION SYSTEM

GAS PIPE - SEDIMENT TRAP MISSING

Sediment trap could not be located on the gas pipe for the appliance. This trap is intended to prevent excess debris (sediment) from entering the unit and causing an issue with the system. Recommend adding sediment trap. See photo(s).

Contact a qualified plumbing contractor.

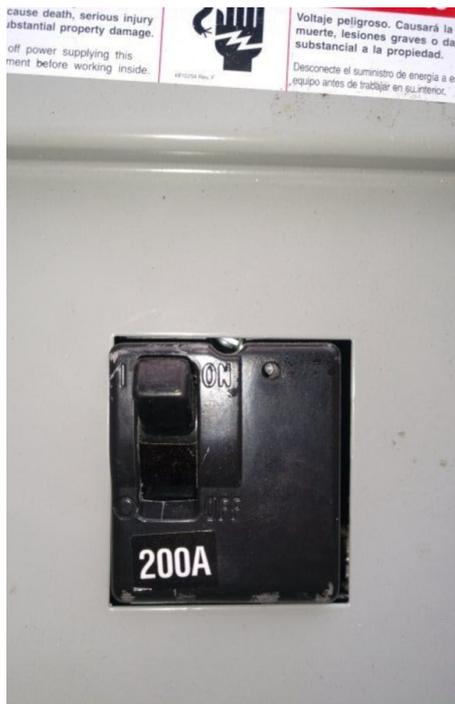
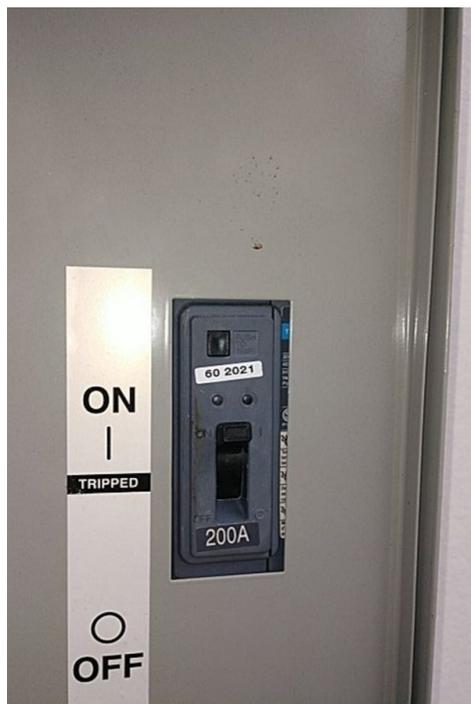
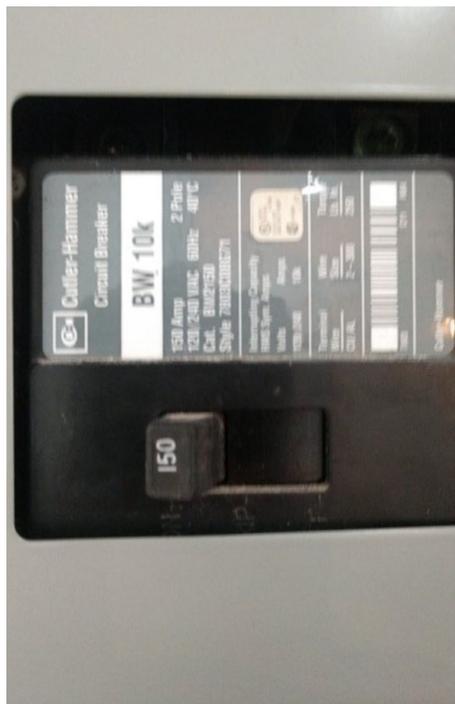
Photo of Panel Capacity.

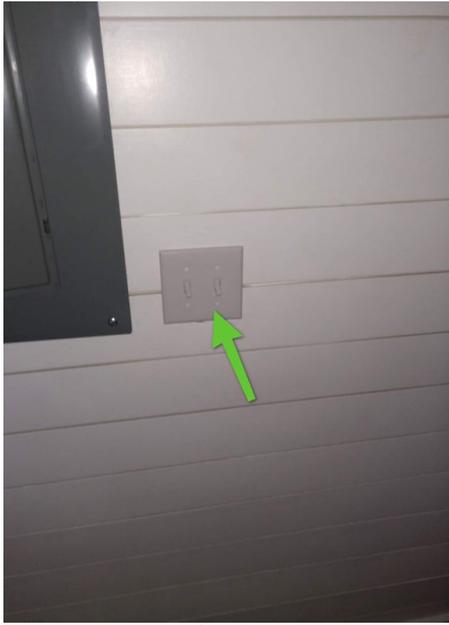
Laundry Room

Unsure of what this switch controls. Have current owner demonstrate what these switches control prior to closing. See photos.

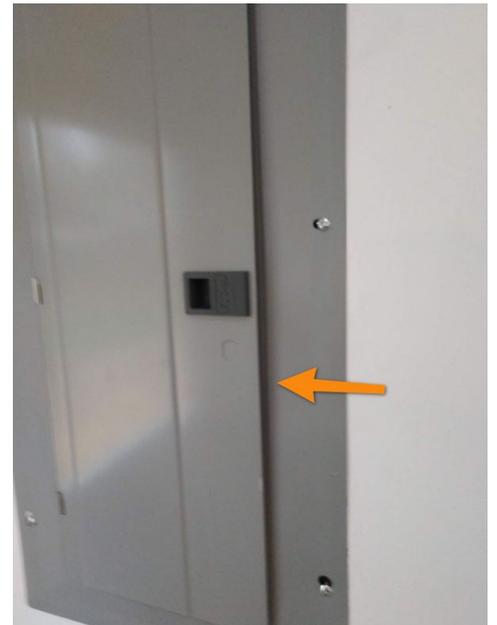
Kitchen

8.3.2 MAIN/SUB PANELS & DISCONNECT BOXES

Electrical panel door does not close correctly. Repair as needed. See photo.

Contact a qualified professional.

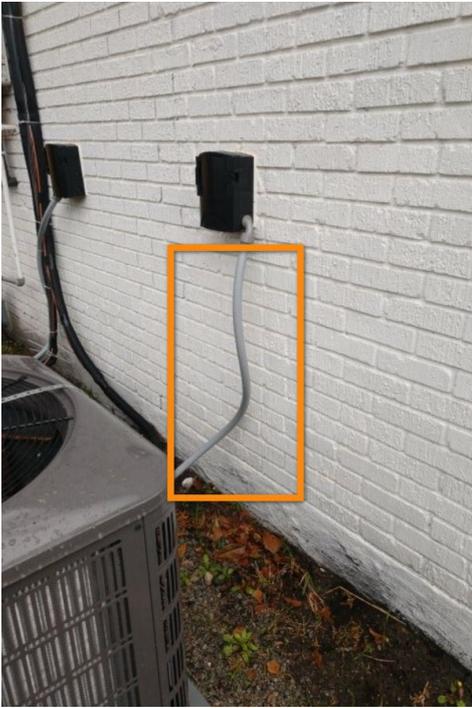
Left Side

8.4.1 CONDUIT

Conduit is loose. Conduit needs to be secured to structure to help prevent being pulled loose or damaged. See photo(s).

Contact a qualified professional.

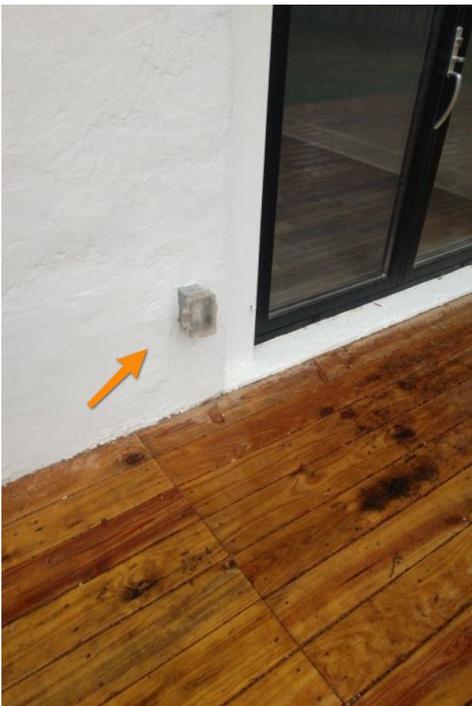
Rear

8.6.1 SWITCHES / OUTLETS

OUTLETS - LOOSE TO WALL

Outlet(s) loose to the wall. Loose outlet boxes can allow wiring connections to move. Have all loose boxes secured for safety. See photo(s) for example(s).

Contact a qualified electrical contractor.

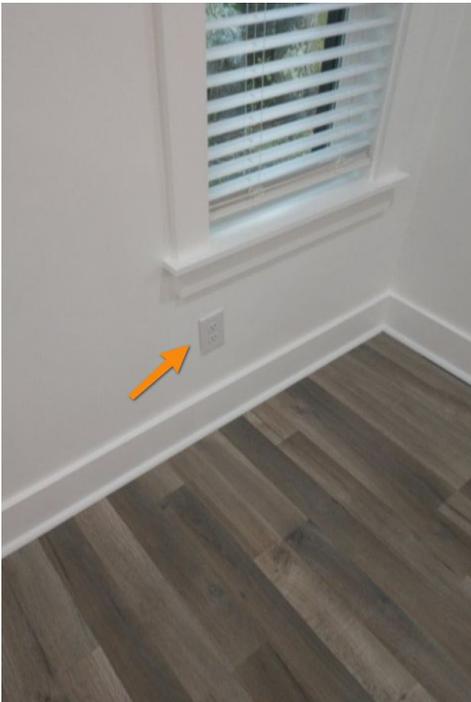
Front Right Bedroom

Outlet(s) did not have power at time of inspection. Unable to fully determine if this is a loose connection, defective outlet, or possibly a defective breaker. See photo(s).

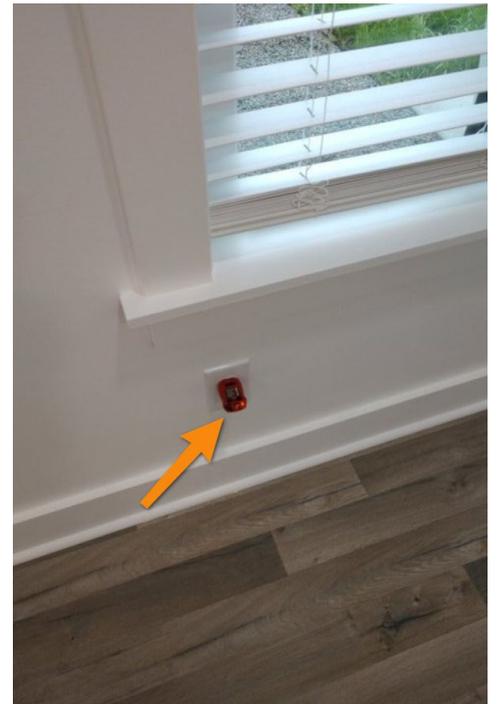
Front Right Bedroom

8.6.4 SWITCHES / OUTLETS

Outlet(s) not properly grounded. A non-grounded outlet is a potential shock hazard. Recommend to have this condition corrected for safety. See photo(s) for example(s).

Contact a qualified electrical contractor.

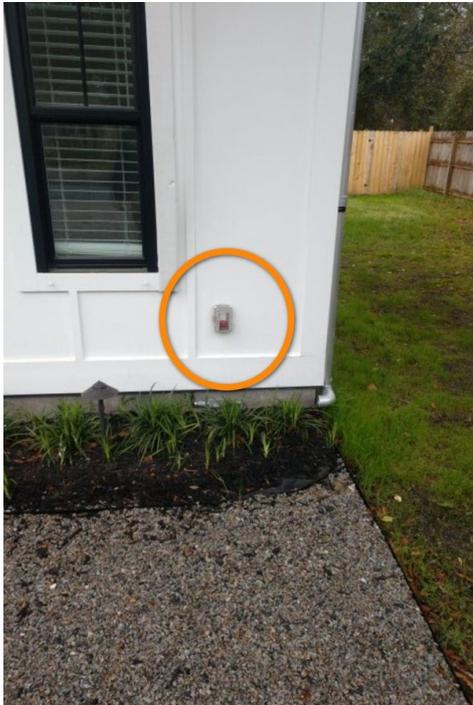
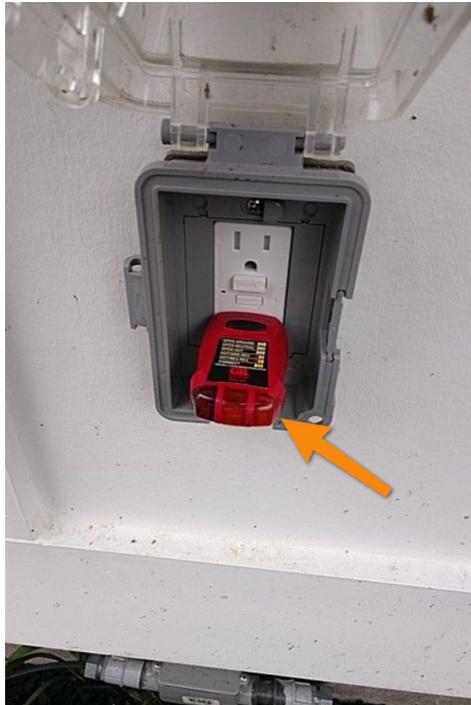
Front

GFCI would not reset after being tripped. Repair needed. See photo.

Contact a qualified electrical contractor.

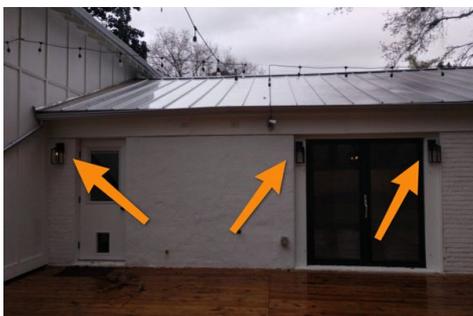
Rear

8.9.1 FIXTURES / CEILING FANS

LOOSE LIGHT FIXTURE

Light fixture is loose and needs to be secured properly. This is a safety concern. See photo(s).

Contact a qualified electrical contractor.

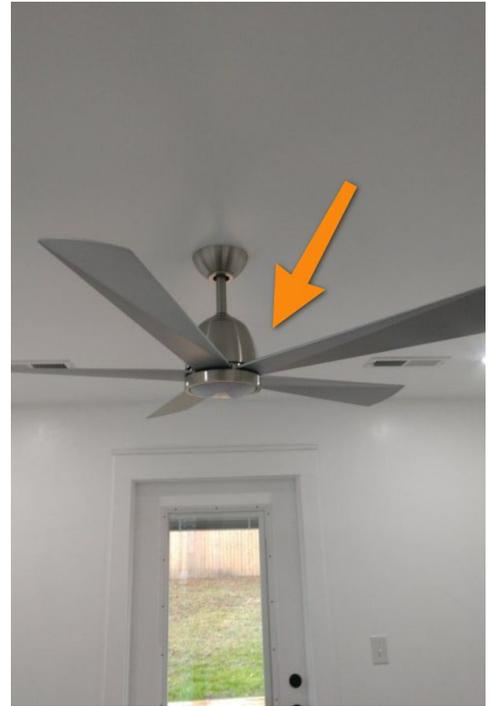
Left Rear Bedroom

NOT TESTED SINCE THE REMOTE WAS NOT FOUND

Ceiling fan was not tested since the remote was not found. Recommend homeowner demonstrate fan is operational. See photo.

Contact a qualified professional.

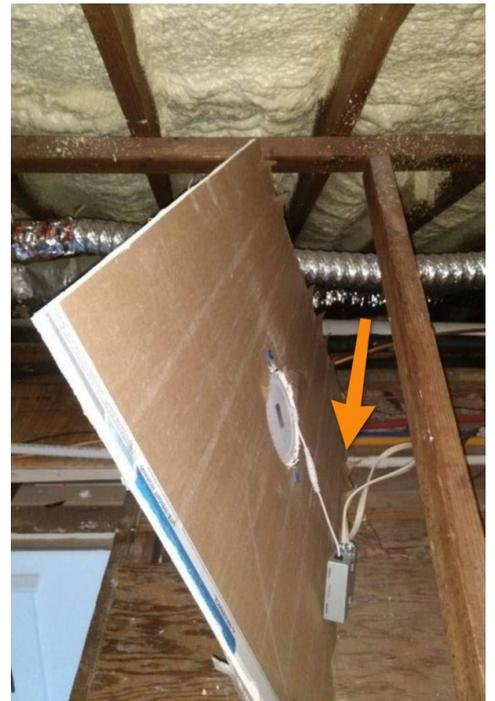
8.9.3 FIXTURES / CEILING FANS

Light installed in removable attic hatch. Excessive movement of hatch could cause wiring to be stressed. Repair as needed. See photo.

Contact a qualified professional.

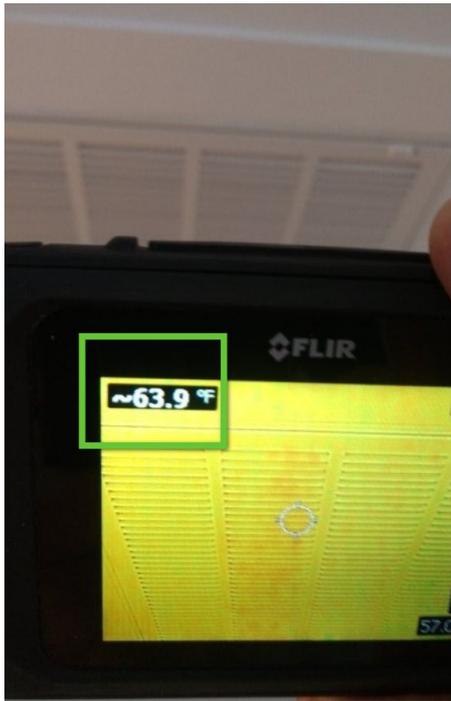
Return Left

A/C appeared to cool properly

Normal temperature differential for AC system is generally between 12-22 degrees.

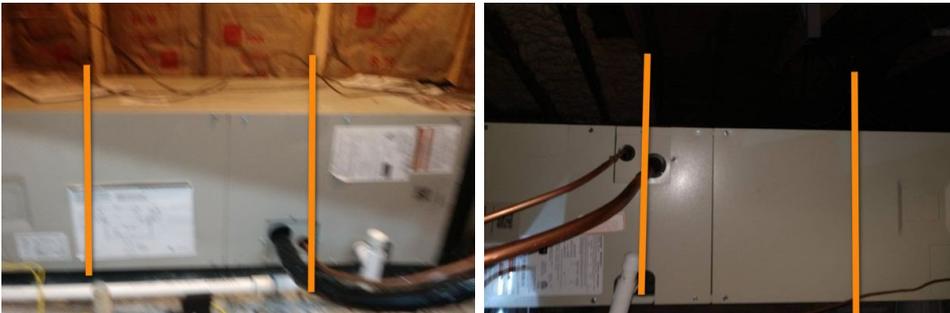
Gaps noted on the insulation around the refrigerant pipes at the air handler(s). The insulated line contains very cold refrigerant. Insulation around all open gaps help prevent condensation from forming and dripping onto the area below. See photo(s).

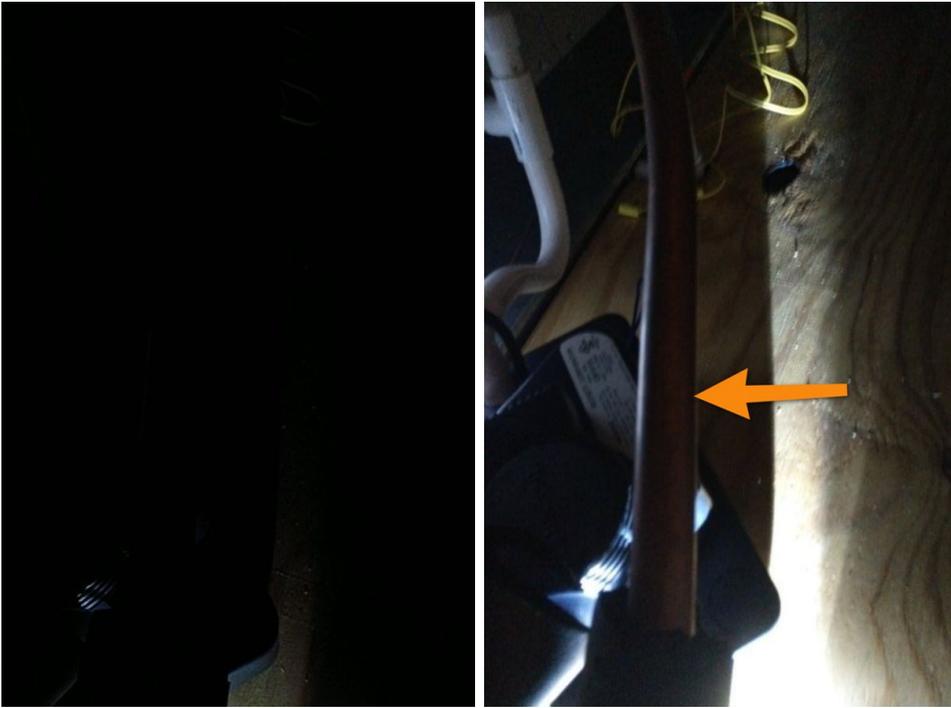
9.2.2 HEAT/AIR HANDLER UNITS

REFRIGERANT LINE - INSULATION GAPS

Contact a qualified professional.
