STEP BY STEP INSPECTIONS

RESIDENTIAL INSPECTION

1733 Combahee St
Charleston, SC 29412

Neil Girardi
MARCH 16, 2022

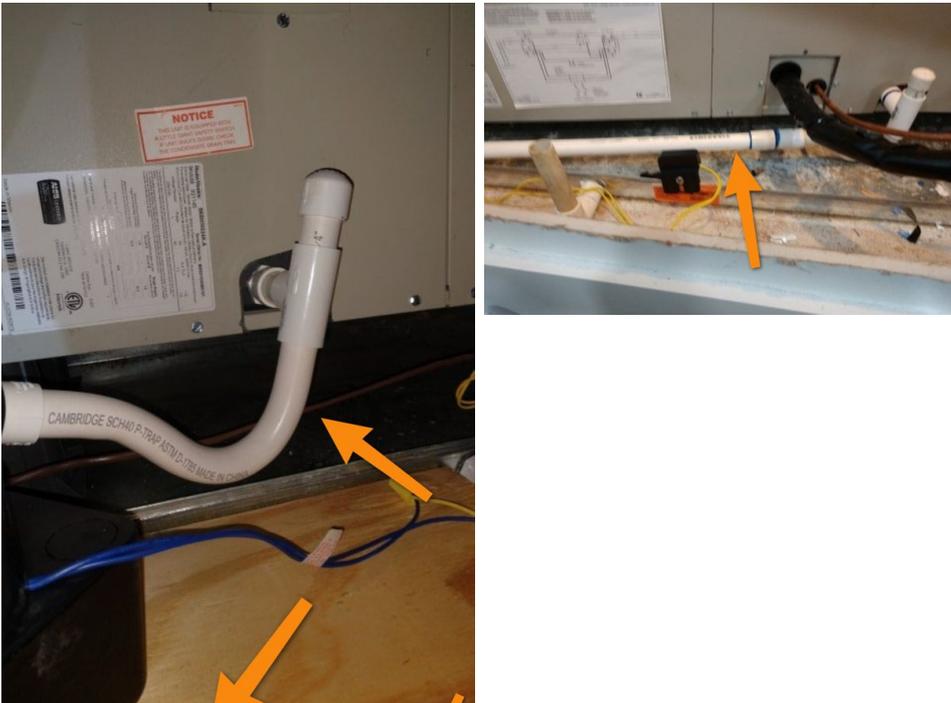
Left Side

9.2.3 HEAT/AIR HANDLER UNITS

CONDENSATE DRAIN PIPE NOT FULLY INSULATED

Condensate drain pipe is not fully wrapped in insulation. Moisture stains / concerns can occur. See photo.

Contact a qualified professional.

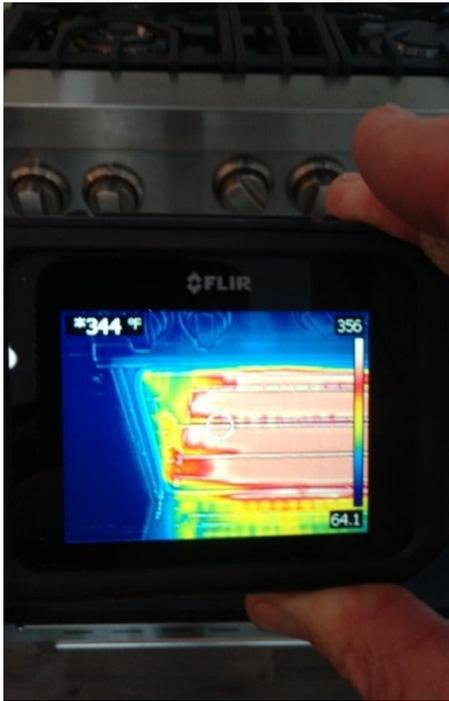
Oven was operational at time of inspection. Unit was tested for basic function. See photo.

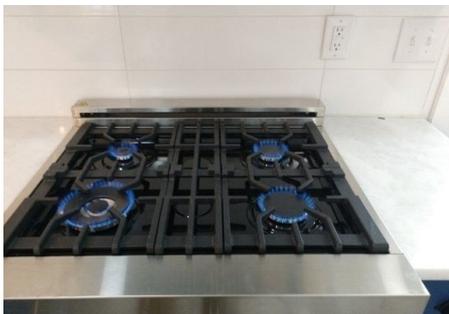
Range was operational at time of inspection. Unit was tested for basic function. See photo.

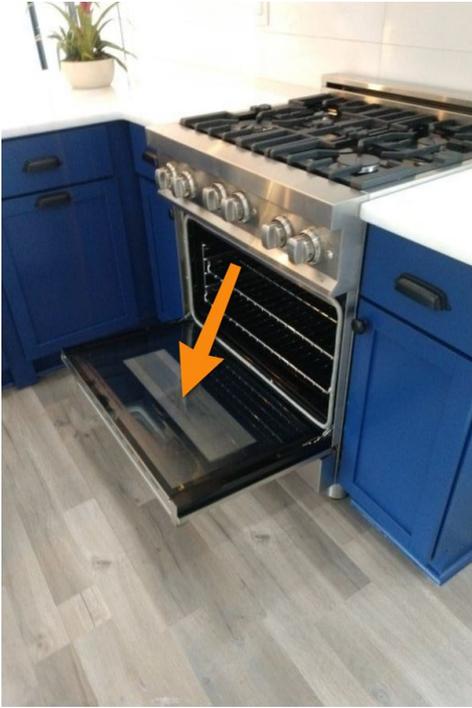
**Recommendations****11.3.1 RANGES/OVENS/COOKTOPS****ANTI-TIP BRACKET**

Oven can tip forward when pulling out large items. Installing an anti-tip bracket may help correct this condition.

Contact a qualified professional.

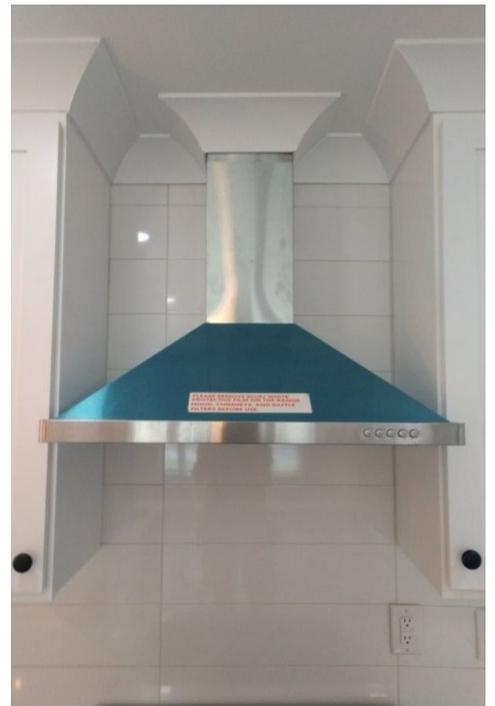
Kitchen

11.4.1 VENT HOOD/DOWN DRAFT

DEFECTIVE VENT HOOD

Contact a qualified appliance repair professional.
